**A Report on Wetlands and Other Aquatic
Habitats Occurring along the San
Francisco Bay Area Rapid Transit District
Proposed Warm Springs Extension**

August 2002

DRAFT
BART Warm Springs Extension
Wetlands and Other Aquatic Habitats

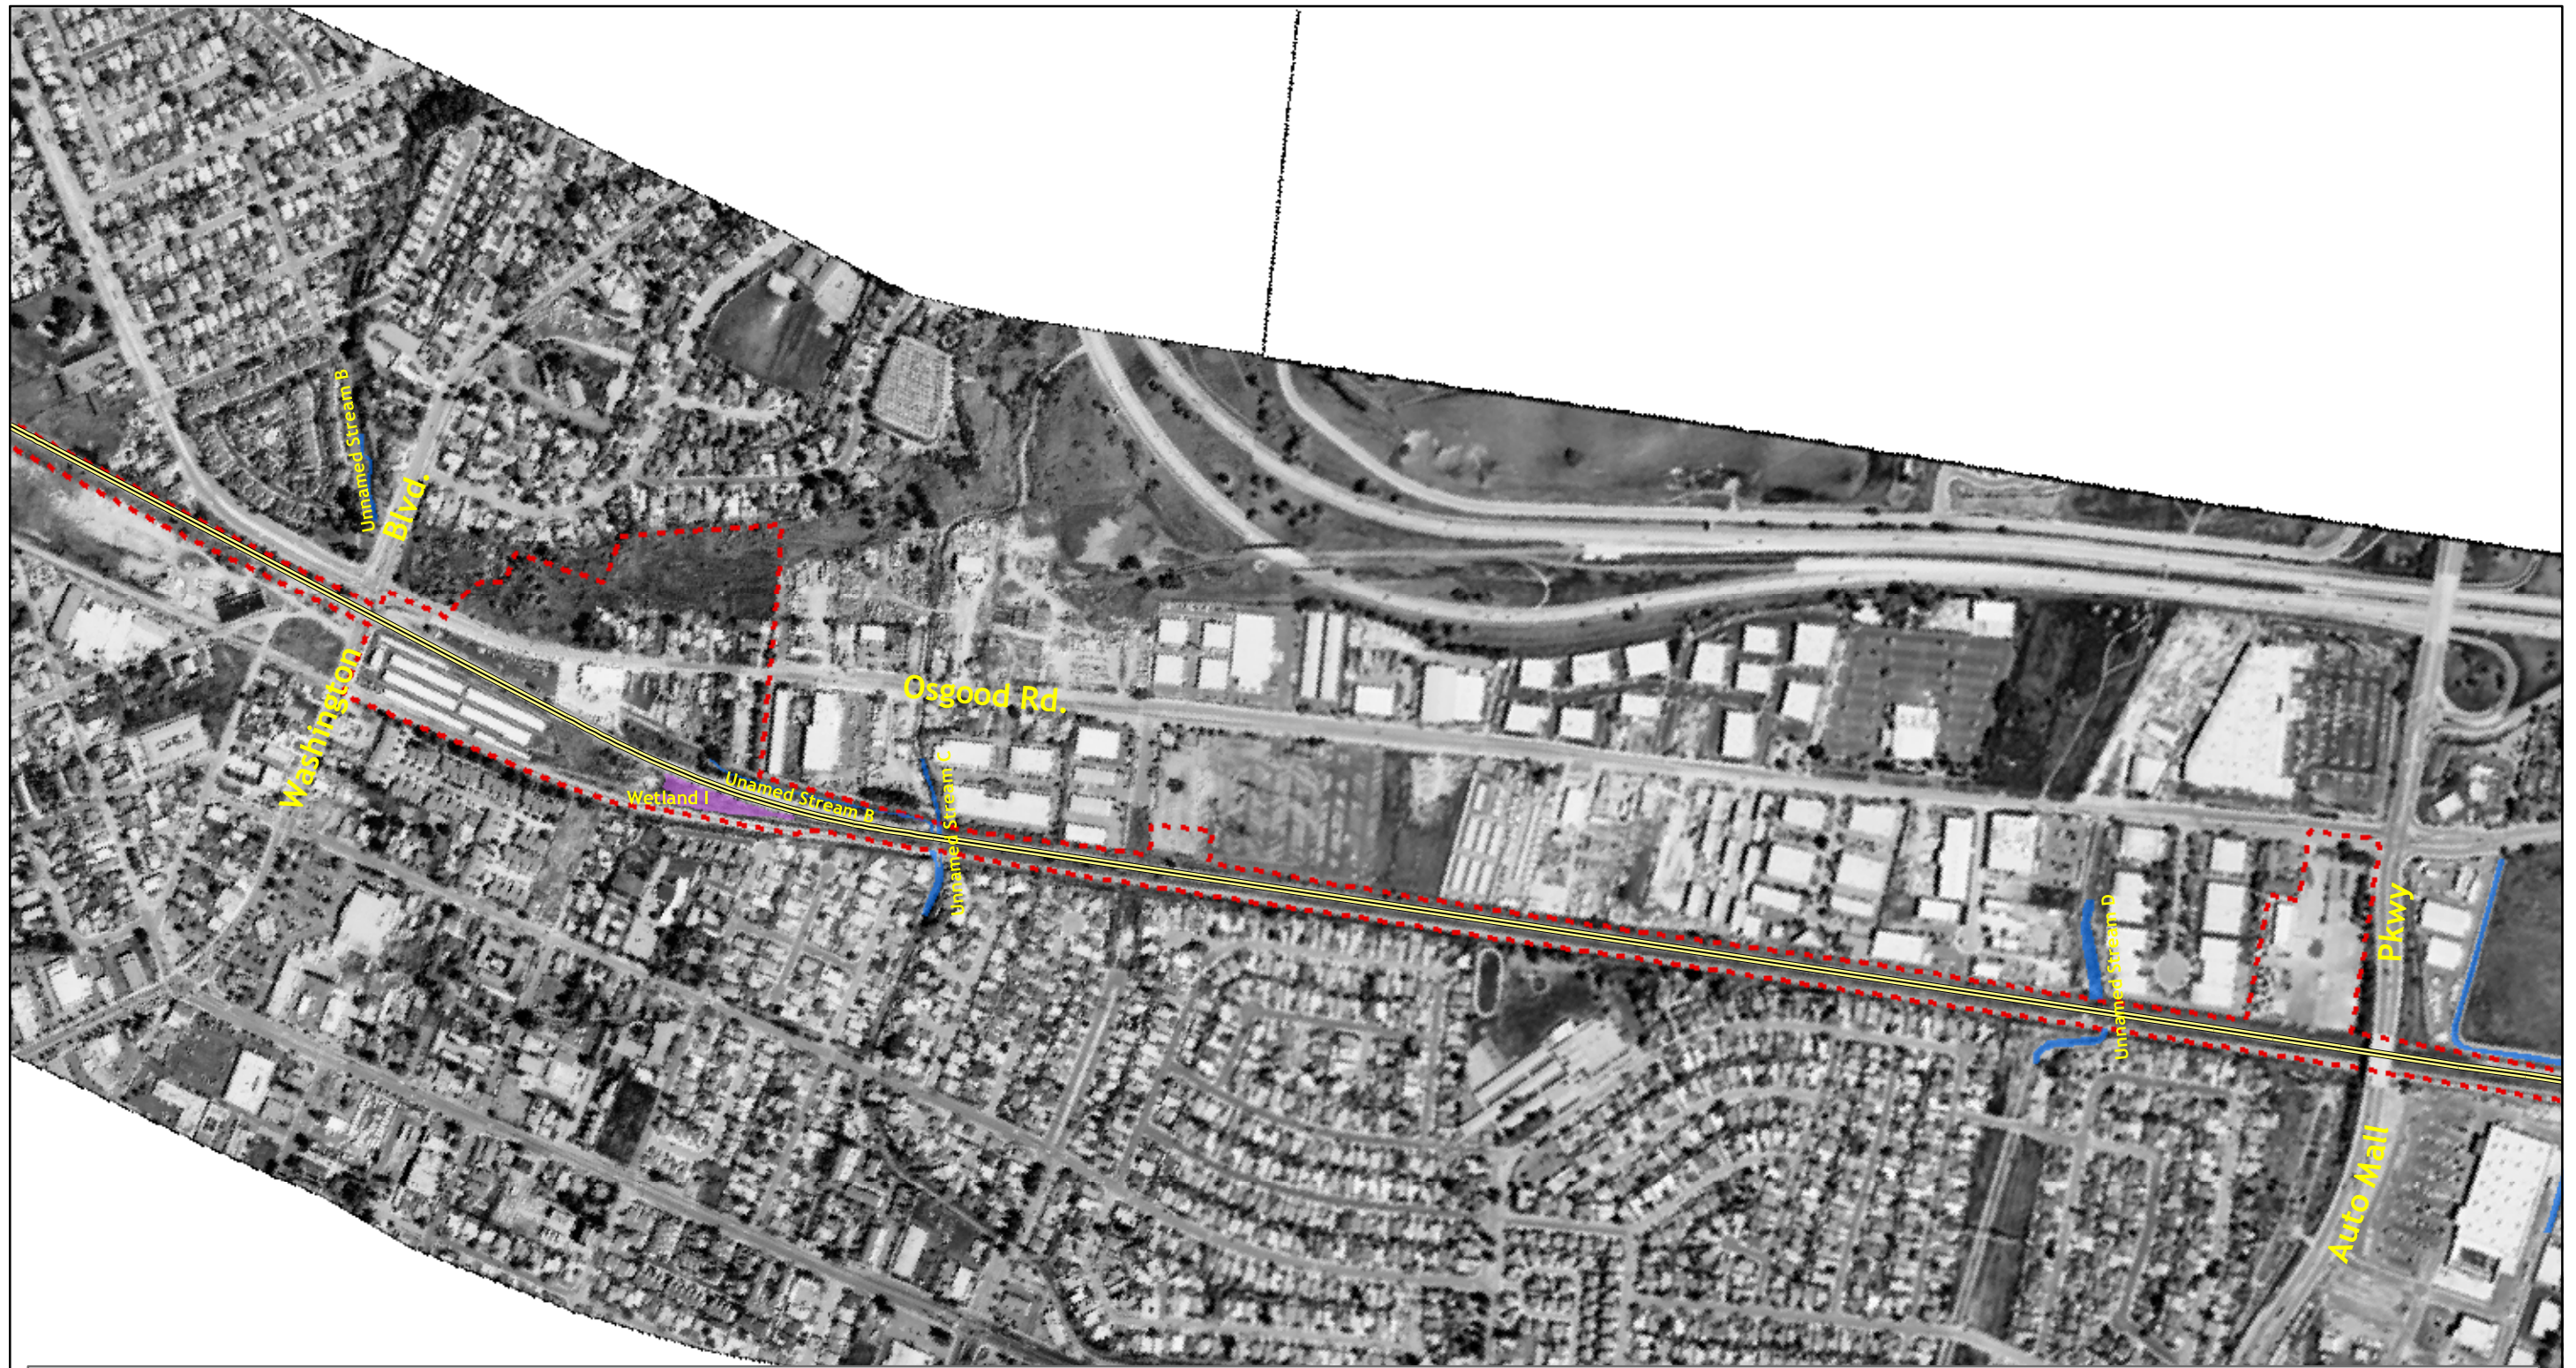
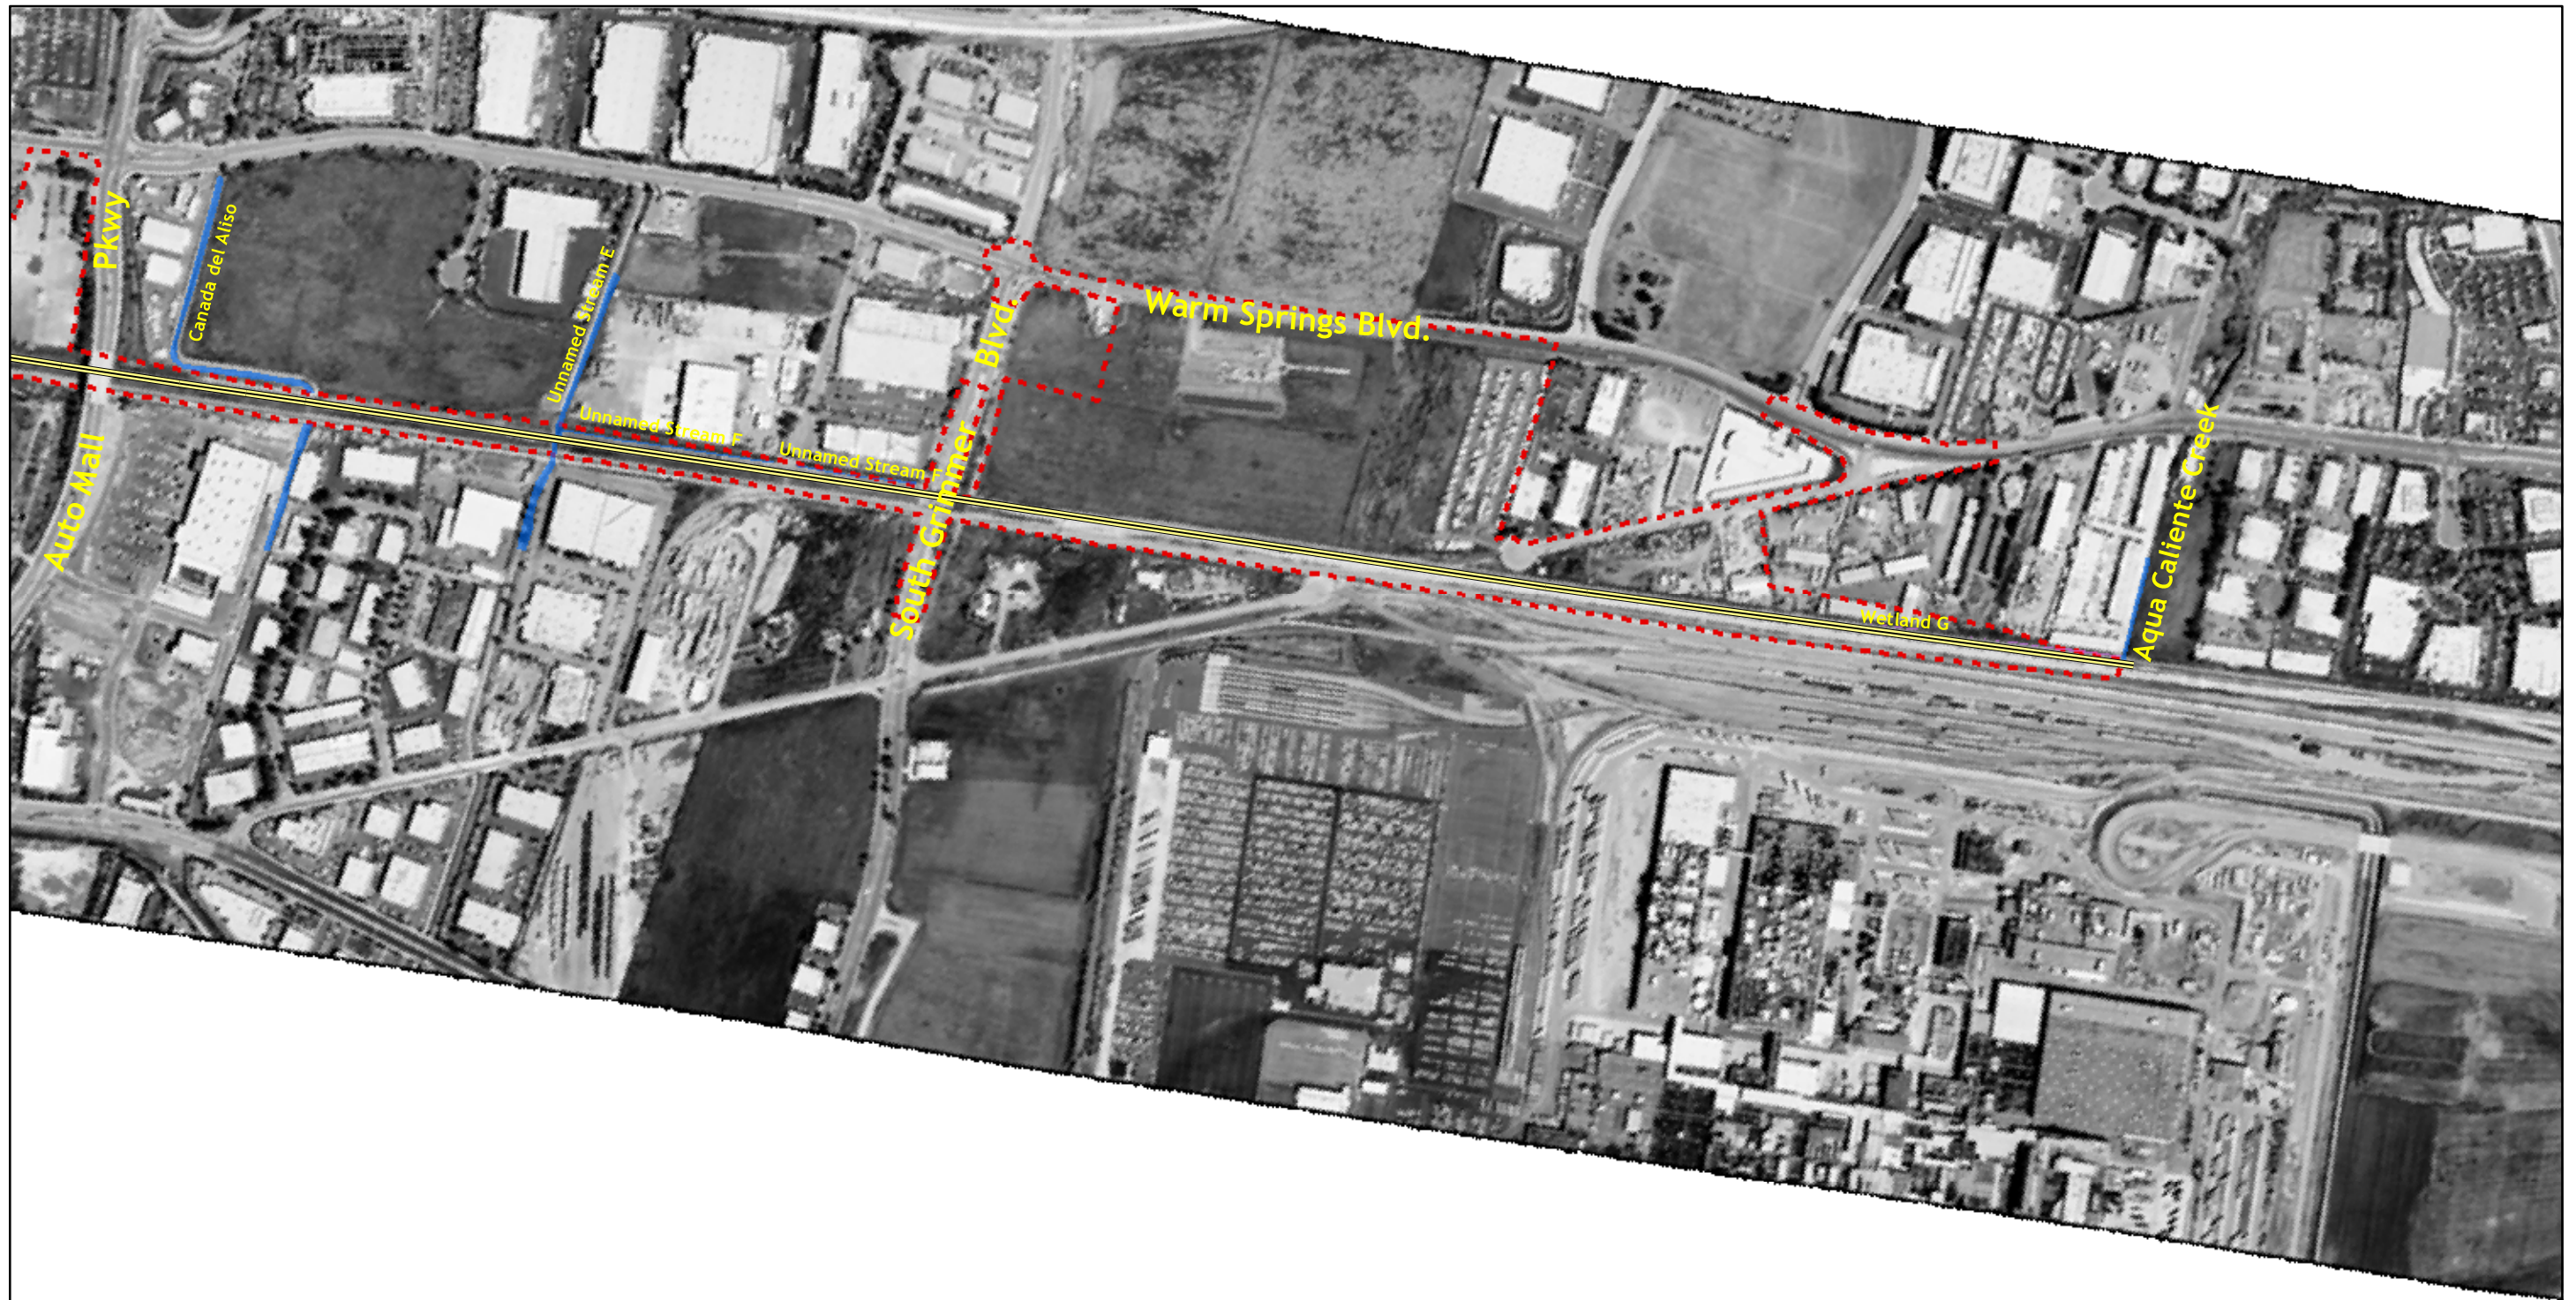
Tule Pond (shown in Figure 1) is a natural sag pond that was bisected by the construction of Walnut Avenue. The remnant of Tule Pond south of Walnut Avenue is no longer permanently flooded but serves as a flood control basin. Seasonal wetlands at Tule Pond are dominated by hard-stem bulrush (*Schoenoplectus acutus*) and smartweed (*Polygonum* sp.). (See Data Points A

Palustrine emergent wetlands (Wetlands B, D, and E, shown in Figure 1) are present on the north side of Paseo Padre Parkway, both north and south of the Hetch Hetchy Aqueduct (Huffman & Associates 2002). In these wetlands, the dominant species include smartweed, bristly ox-tongue (*Picris echioides*), curly dock (*Rumex crispus*), and poison hemlock (*Conium maculatum*). The herbaceous uplands at this location consist primarily of annual grassland dominated by Italian ryegrass, in association with bird's-foot trefoil (*Lotus corniculatus*), bristly ox-tongue, curly dock, field bindweed (*Convolvulus arvensis*), bull thistle (*Cirsium vulgare*), and narrow-leaved milkweed (*Asclepias fascicularis*).

Palustrine emergent wetlands (Wetland F, shown in Figure 1) are present in the railroad right-of-way south of Washington Boulevard (Huffman & Associates 2002). In these wetlands, the dominant species include creeping spikerush (*Eleocharis macrostachya*), curly dock, swamp timothy (*Crypsis schoenoides*), and umbrella sedge (*Cyperus eragrostis*). The adjacent upland vegetation is ruderal, dominated by Italian ryegrass and Bermuda grass (*Cynodon dactylon*), in association with stinkweed (*Dittrichia graveolens*), curly dock, scarlet pimpernel (*Anagallis arvensis*), Mediterranean mustard (*Hirschfeldia incana*), and wild oat.

Palustrine emergent wetlands (Wetland G, shown in Figure 1) are also present in a narrow toe drain along the railroad right-of-way north of Mission Boulevard. (See Data Points 3 and 4 in Appendix A.) In these wetlands, the dominant species include Italian ryegrass and bristly ox-tongue. The vegetation is only marginally hydrophytic, but patches of strongly hydrophytic vegetation, including narrow-leaved cattail (*Typha angustifolia*) and umbrella sedge occur along the drainage in which this wetland is located. Upland species are absent from the drainage channel. The adjacent uplands are dominated by ruderal species, including Bermuda grass and sweet fennel (*Foeniculum vulgare*).
